LAKE VALENTINE DAM

NJ 00297

PHASE 1 INSPECTION REPORT
NATIONAL DAM SAFETY PROGRAM

JANUARY 1980

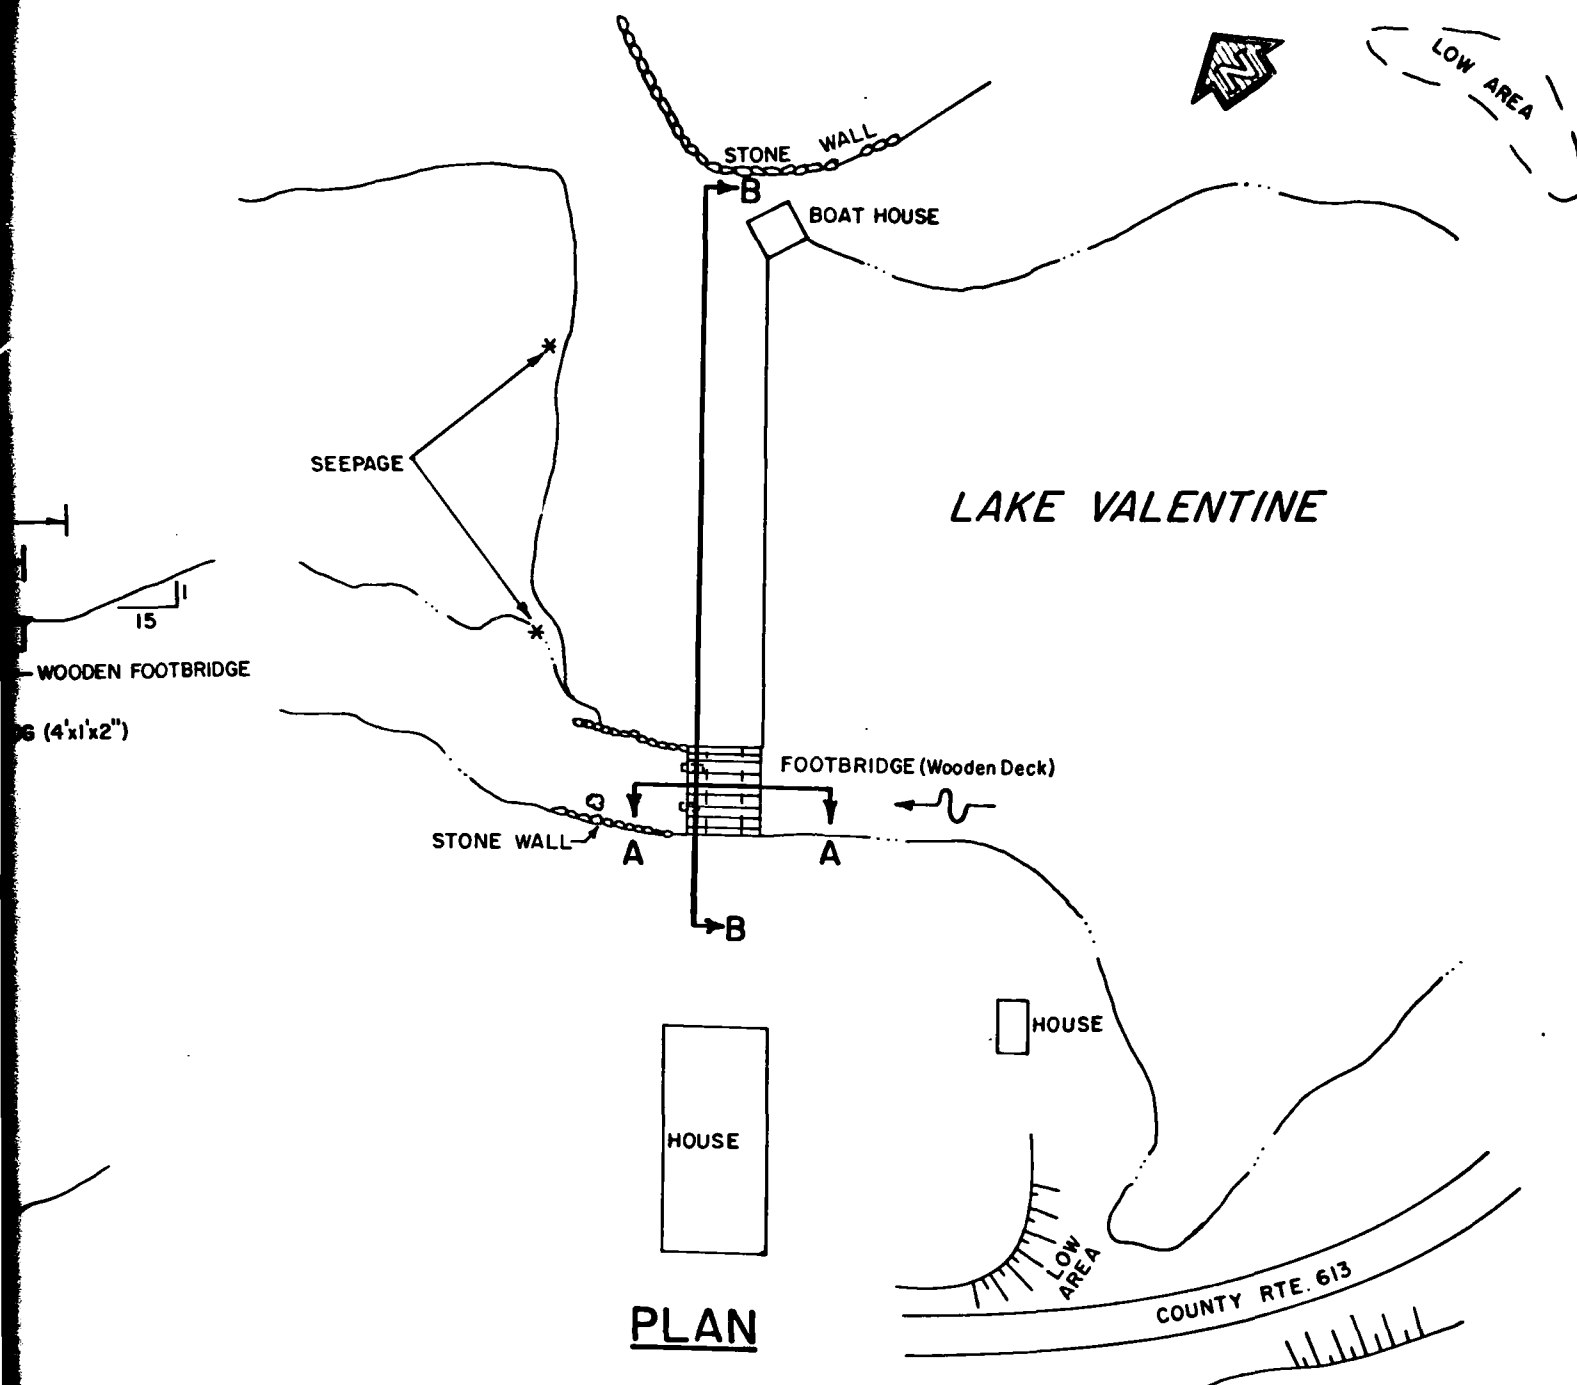
FIGURE 1

DATA FROM FIELD INSPECTION 11/9/79
